SIB 33 02 22

## UPDATE: SWINGARM DRAIN RETROFIT AND DRIVE SHAFT CHECK

This Service Information Bulletin replaces SIB 33 02 22 **dated Fed 3rd, 2023**

Model	Model Description
K50	R 1200 GS / R 1250 GS
K51	R 1200 GS Adventure / R 1250 GS Adventure
K52 Authority	R 1200 RT Authority / R 1250 RT Authority

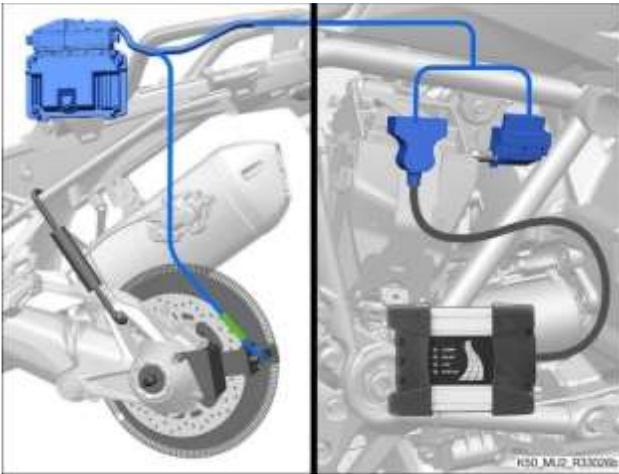
*Measuring setup*

This test method is used to check the functional health of the driveshaft while installed in the vehicle and measures the vibrations of the rear-wheel flange to detect damage in universal joints or gearing.

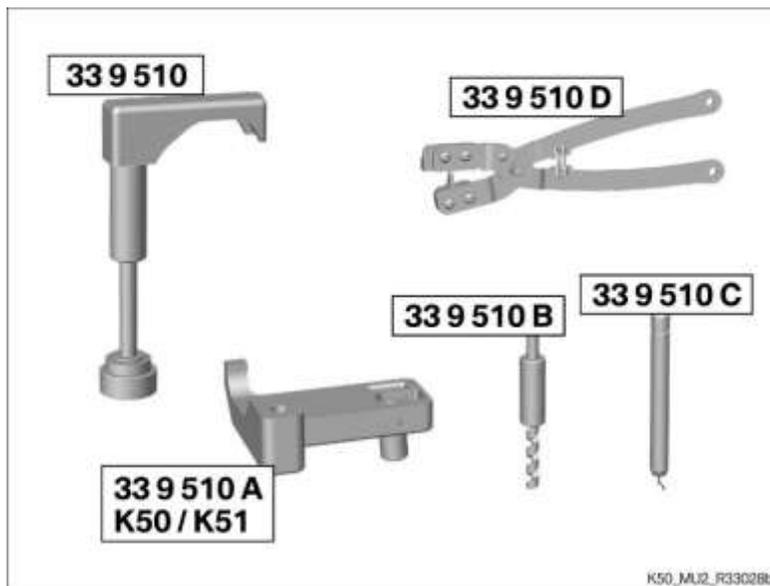
- Bow with threaded rod
- Bottom shell A
- Drill with bush B
- Universal deburring tool C
- Set of pliers D

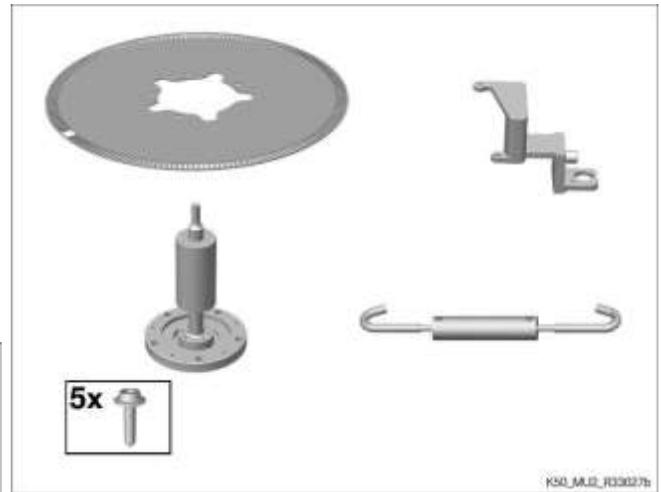
- Hook
- Sensor bracket
- Wheel flange adapter with screws
- Sensor wheel

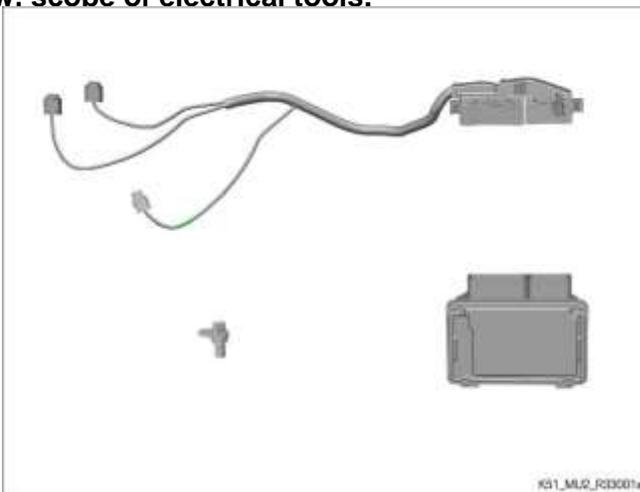
**Overview. scope of electrical tools:**

- Measuring wiring harness
- Measuring control unit
- Speed sensor

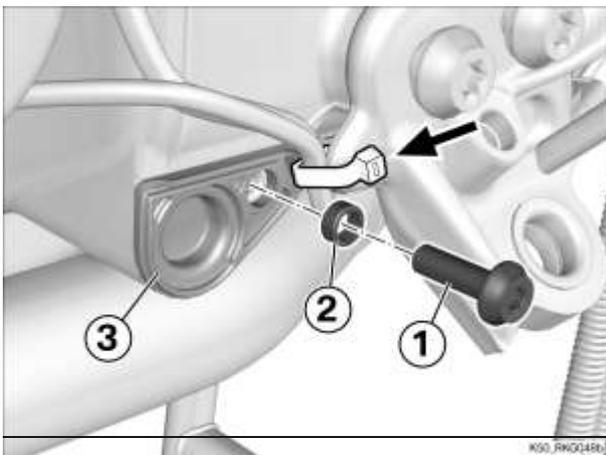
- Remove cable strap (arrow).
- Remove bolt (1) and bush (2).
- Loosen cable duct (3).

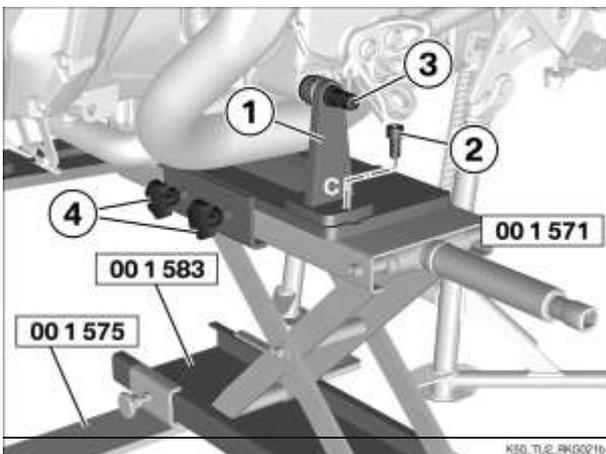
- Install mounting C (1) with bolt (2).
- Secure the engine fixture with screw (3).
- Install scissor-type lifter (001571) with rail (001583) and extensions (001575).
- Tighten knurled screws (4).

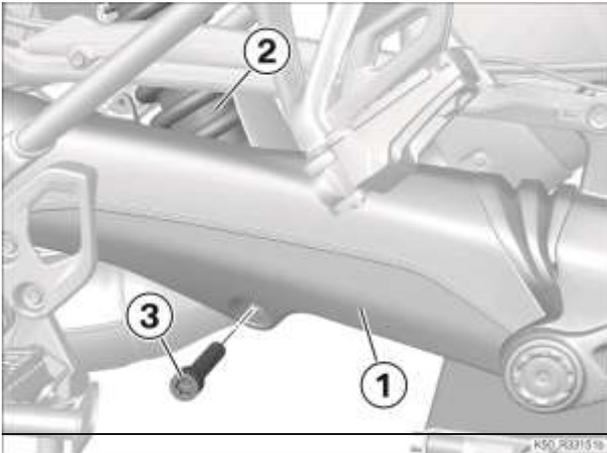
► **Loosening suspension strut from rear wheel swinging arm**

- Raise rear wheel swinging arm (1) with tension hook until suspension strut (2) is relieved.
- Remove screw (3).
- Loosen suspension strut (2) from rear wheel swinging arm (1).

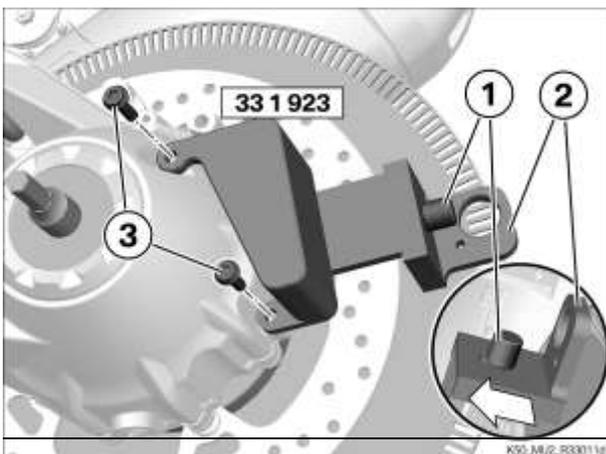
- Loosen knurled screw **(1)** and push back carriage **(2)**.
- Secure sensor bracket (33 1 923) with screws **(3) hand-tight**.
- Screws M6x16

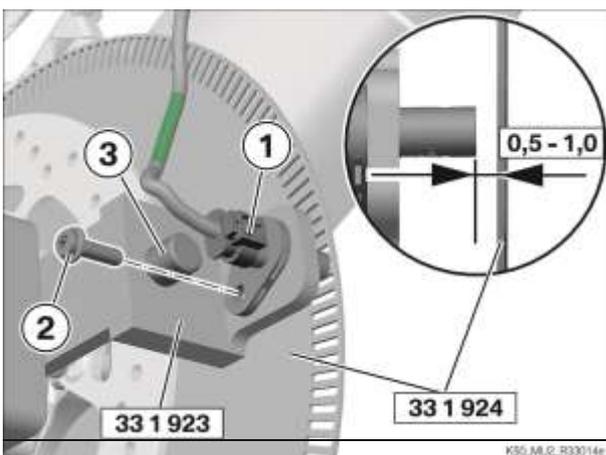
- Secure speed sensor **(1)** with suitable screw **(2)** in sensor bracket **hand-tight**. Screw, M6 x 12
- Adjust distance setting between speed sensor **(1)** and sensor wheel, tighten knurled screw **(3)**.
- Distance setting 0.5mm - 1.0mm**
- Spin sensor wheel several times and measure distance **circumferentially**.
- If the sensor wheel has lateral runout and the distance cannot be maintained, the sensor wheel must be replaced.

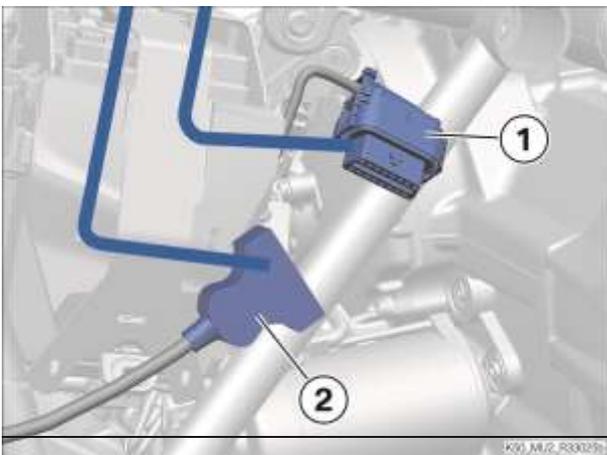
- Follow sequence!
  - First, connect all connectors.
  - Only after that, switch on ignition and start service function.
- Loosen analysis connector (1).
- Connect measuring wiring harness on vehicle with analysis connector (1).
- Connect measuring wiring harness with diagnosis system connector (2).

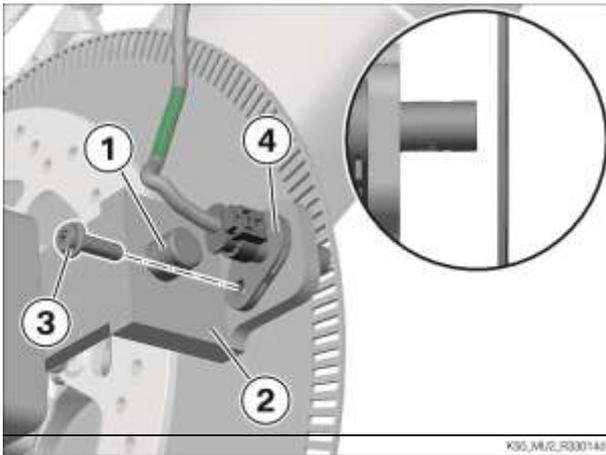
- Slackenknurledscrew (1) and pushback carriage (2).
- Removescrew (3) and loosenspeedsensor (4) from holder.
- **Donotdisconnectconnector!**

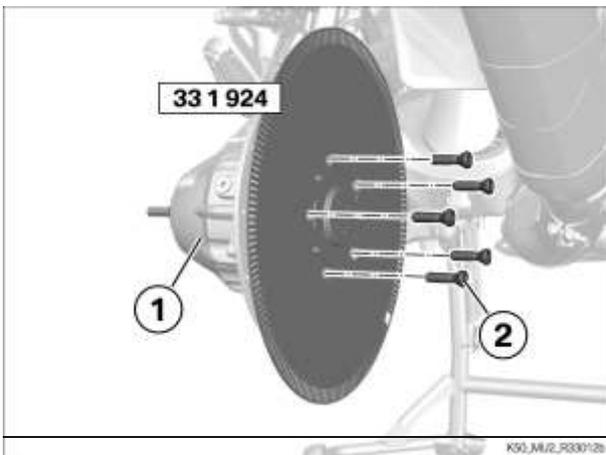
- Always handlesensor wheelwithcare.
- Always setdownsensor wheelon a flatsurface.
- Removewheelbolts (2) and removewheel flange adapterwithsensor wheel from angular gearbox (1).

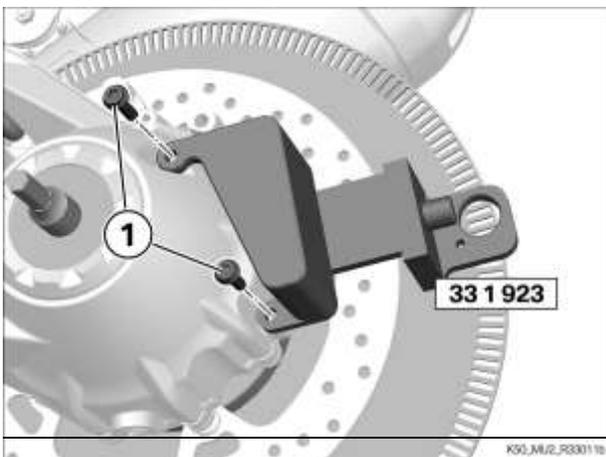
- Removescrews (1) and take off sensor bracket.

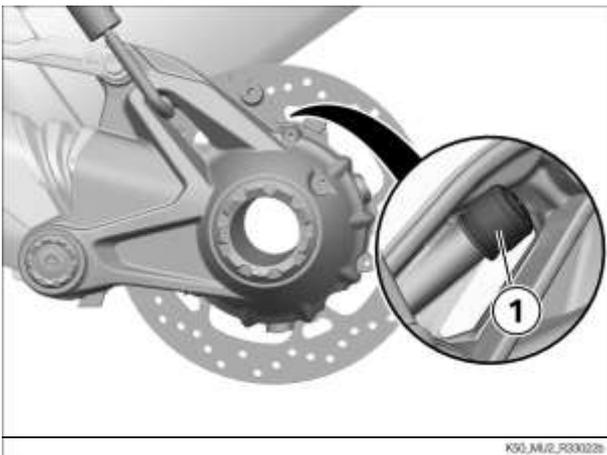
- Check breather (1) for damage, replace as needed.
- Make sure breather (1) is installed correctly.

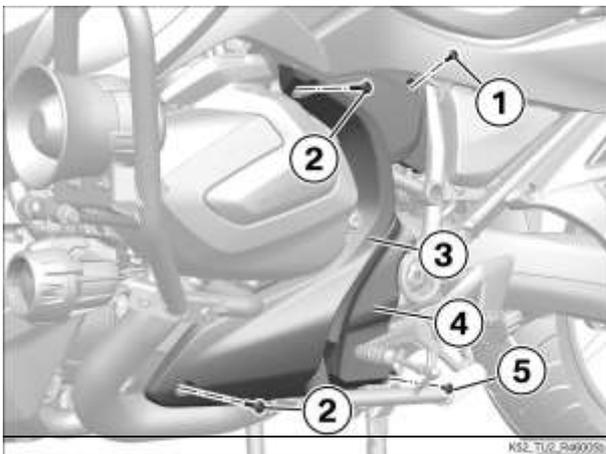
- Remove screws (1), (2) and (5).
- Remove engine spoiler (3) with trim (4).

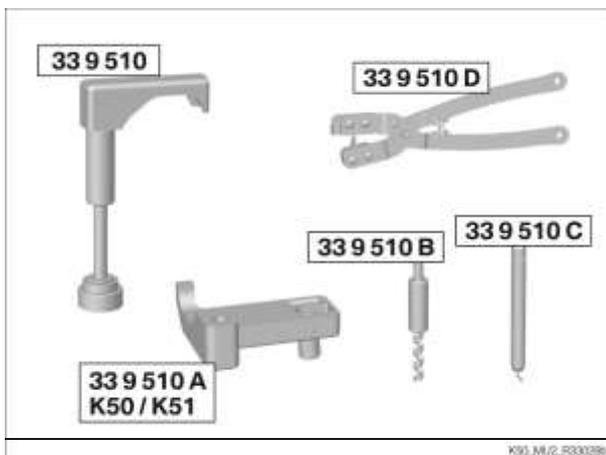
# 2

#### ► Overview, scope of tools

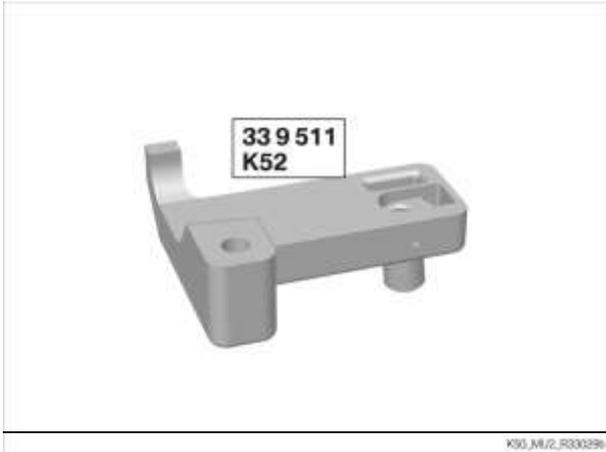
- Bottomshell(339511)
- OnlyK52

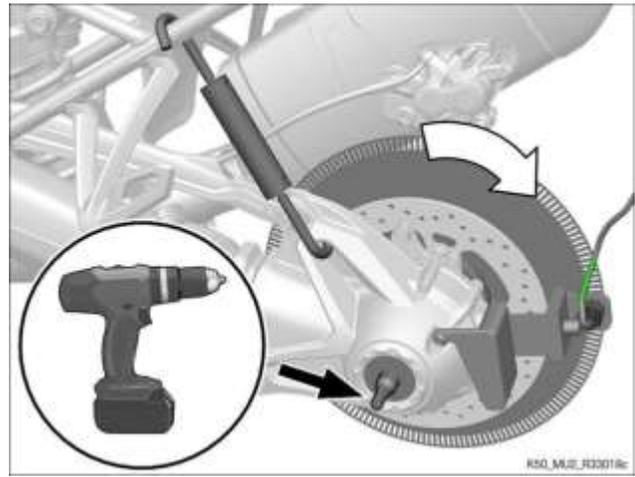
Measuring setup

This test method is used to check the functional health of the driveshaft while installed in the vehicle and measures the vibrations of the rear-wheel flange to detect damage in universal joints or gearing.

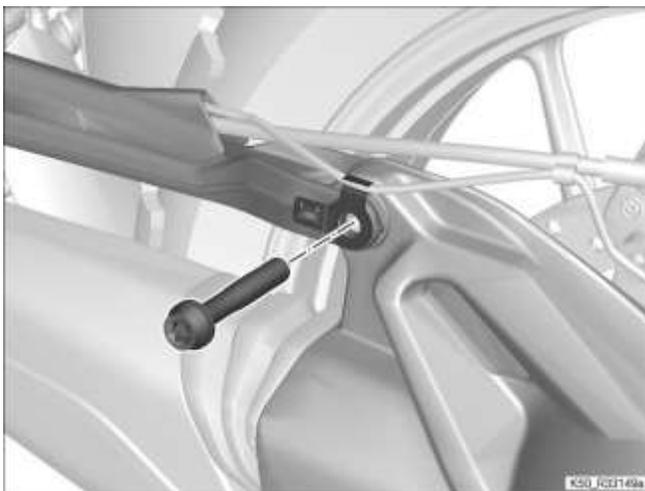
- Brush on Approx. 1 gram of lubricant with brush in recesses of gearing all the way around.
- Apply lubricating material over full length of gearing.

**NOTICE:** The bolting specification for the Paralever link on the rear axle has been changed. The relevant repair instructions in AIR have been updated.

Since the existing screw is being re-used, it is essential to clean the screw as well as the thread in the differential, and use **Loctite 2701** - PN 33 17 2 331 095 when re-installing.

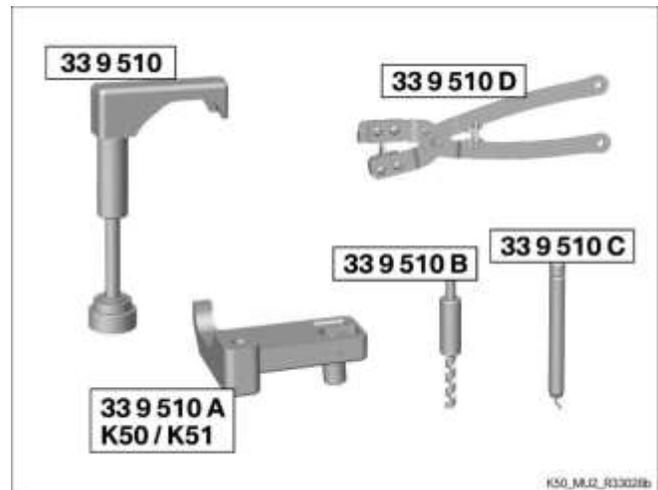
- Bow with threaded rod
- Bottom shell A
- Drill with bush B
- Universal deburring tool C
- Set of pliers D

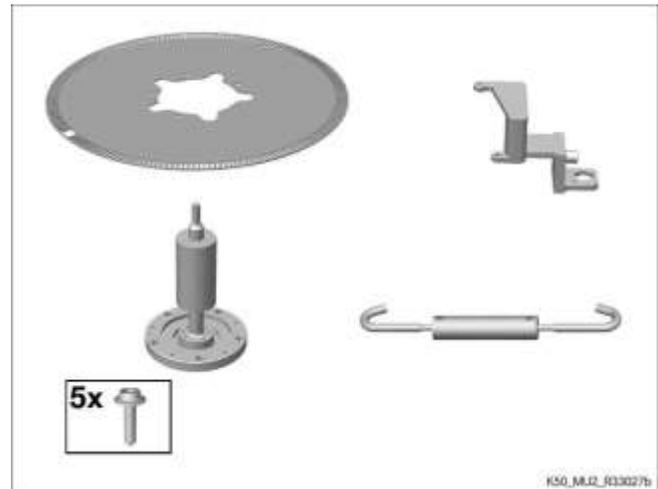
**Overview mechanical tool set (33 1 920):**

- Hook
- Sensor bracket
- Wheel flange adapter with screws
- Sensor wheel

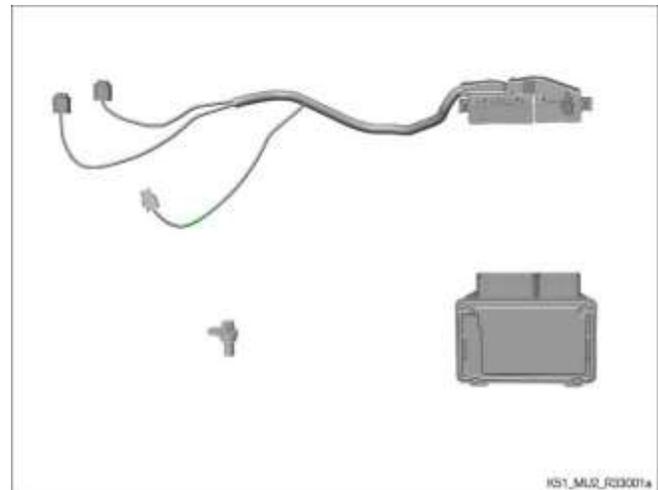
**Overview, scope of electrical tools:**

- Measuring wiring harness
- Measuring control unit
- Speed sensor

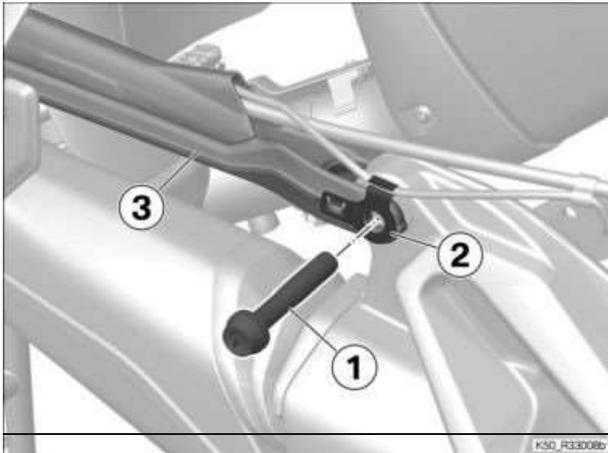
► **Loosening and folding down bevel gears**

- Support bevel gears with tensioning belt or scissor-type lifter.
- Remove (1) old takeoff cable routing (2).
- Loosen Paraleverlink (3).

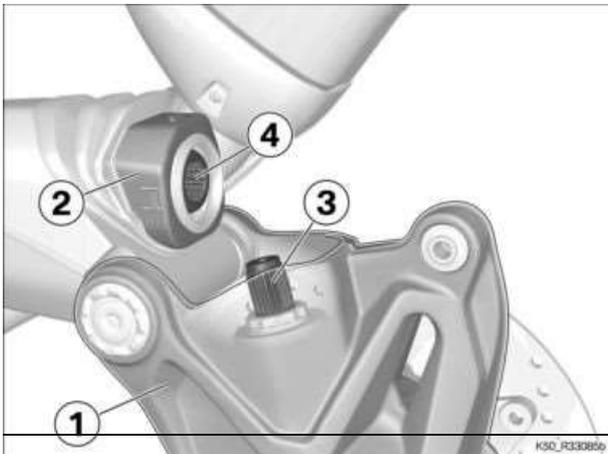
- Lower bevel gears (1) and secure to prevent damage.
- Unclip gaiter (2) from bevel gears (1).
- Pulloff (3) bevel gear from Cardan shaft (4).

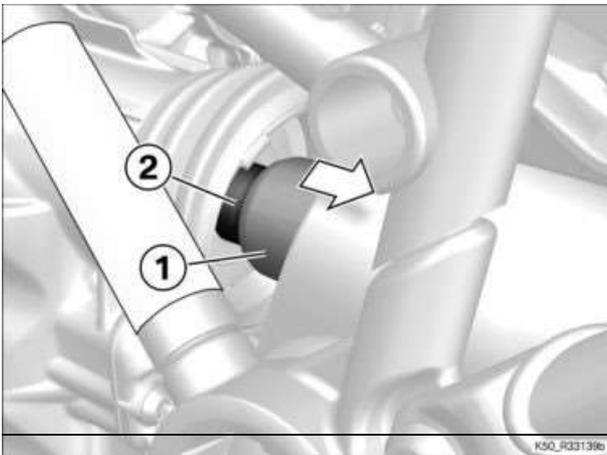
- Loosen Cardan shaft **(1)** with suitable lever tool from transmission output shaft **(2)**:

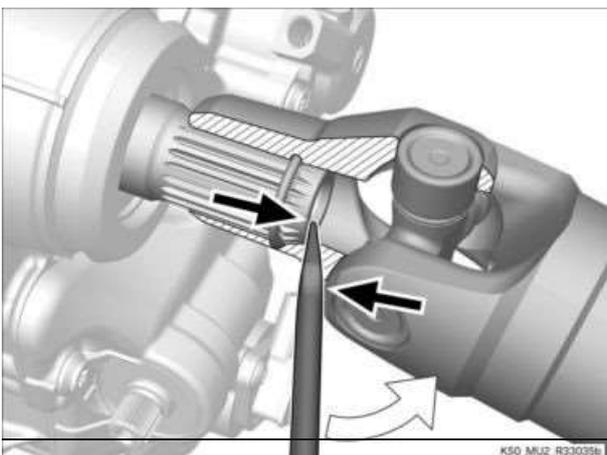
- Position lever tool on universal joint and support on transmission output shaft **(arrows)**.
- Lever the lever tool to the rear.
- » Cardan shaft is pushed off to the rear.

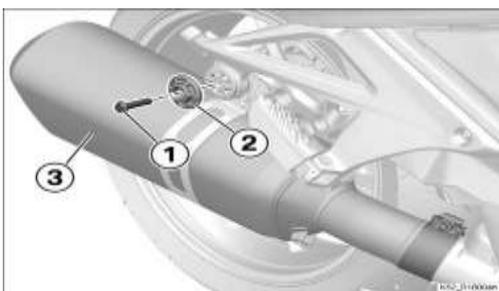
**8**

- ▶ **Removingsilencer**
  - Slackennut (1).
  - Pushclamp (2) totherear.

- Removescrew (1) andwasher (2).
- Removesilencer (3).

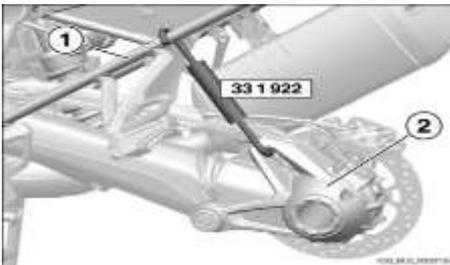
## 15

▶ **Securing angular gearbox on rear frame**

- Hook hooks (33 1 922) on rear frame (1) and angular gearbox (2).

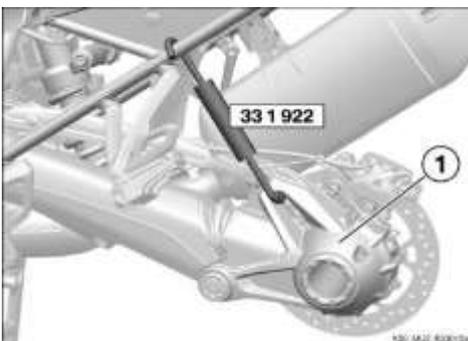
## 17

### ► Lowering rear wheel swingarm for sensor wheel installation

- Lower angular gearbox (1) with hook (331922).

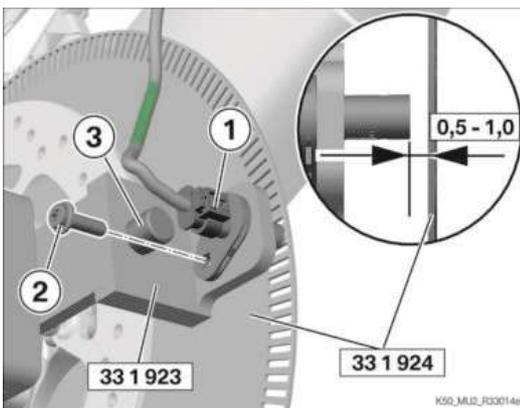
- Secure speed sensor (1) with suitable screw (2) in sensor bracket **hand-tight**.
- Screw, M6x12
- Adjust distance setting between speed sensor (1) and sensor wheel, tighten knurled screw (3).
- **Distance setting 0.5mm-1.0mm**
- Spin sensor wheel several times and measure distance **circumferentially**.
- If the sensor wheel has a lateral runout and the distance cannot be maintained, the sensor wheel must be replaced.

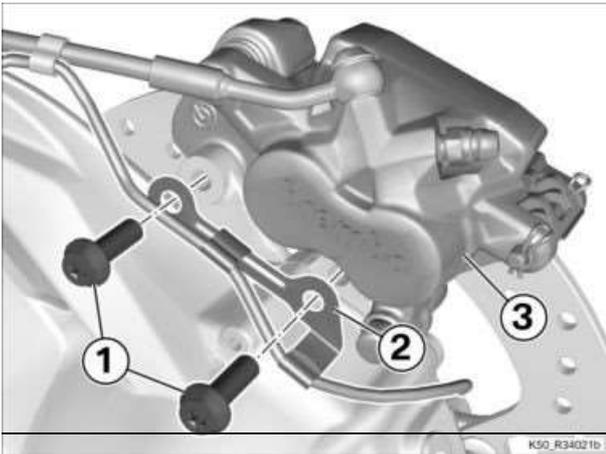
- ◀ • Clean the threads.
- Position the brake caliper **(3)**.
- Position the cable routing **(2)**.
- **Install** new screws **(1)**.

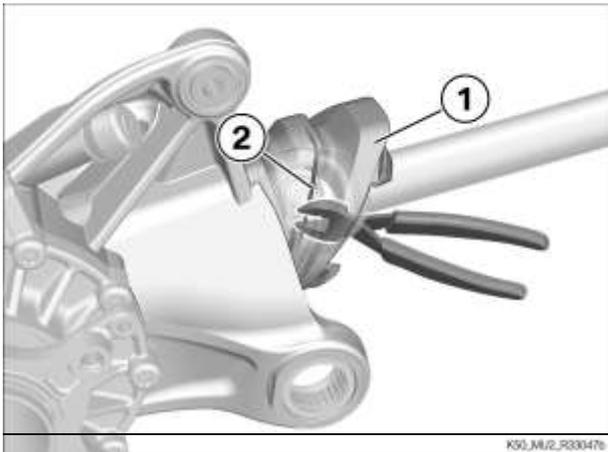
- If necessary, spray the area of the taper splines with rust remover and let it interact before starting work.
  - Active ice rust remover, part number 83 19 22 1 1267.

- Cut through gaiter **(1)** and wiring **(2)** and remove.
  - Loosen gaiter on angular gearbox with rotational movement.

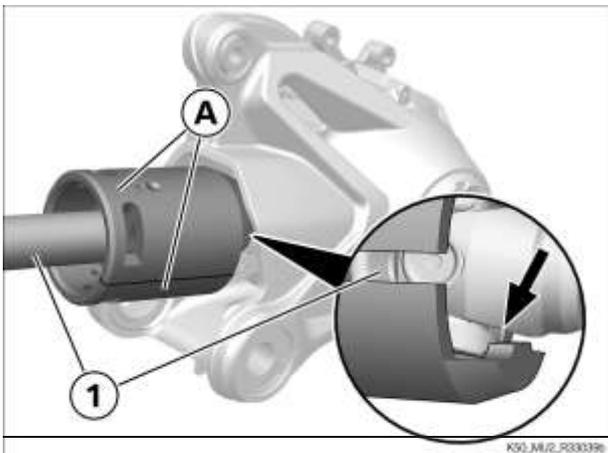
- Position halfshells **(A)** from toolset (261930) on Cardan shaft **(1)**.
